# Manhole Inspection Summary

Manhole # S33EE\_035MH

Insp Date: **2/21/07 9:56 AM**

**Location** Address: **5 PRESTON ST**

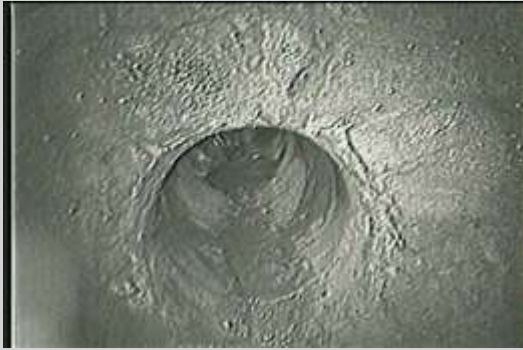
Pipe In @ 7 O'Clock

Pipe Material: **Clay** ☐ Pipe Lined

Invert Depth: **8.20** (ft.) Flow Characteristics: **Fast**

Deposits: ☒ None ☐ Mud ☐ Sludge ☐ Debris ☐ Grease

Infiltration: **None** Pipe Seal Cond: **Unknown**

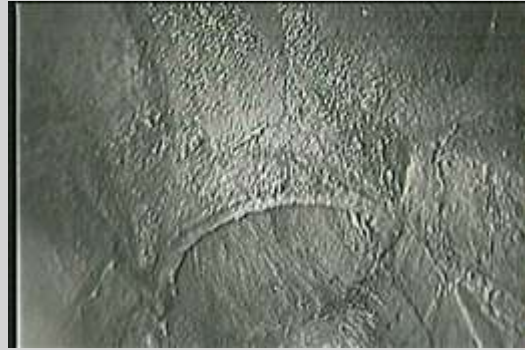
Drop In @ 7 O'Clock

Drop: **Outside** Rod and Bar

Angled: **Yes** Reading: **10.15** (ft.)

Inv Depth: **11.15** (ft.)

Drop Condition: **Open**

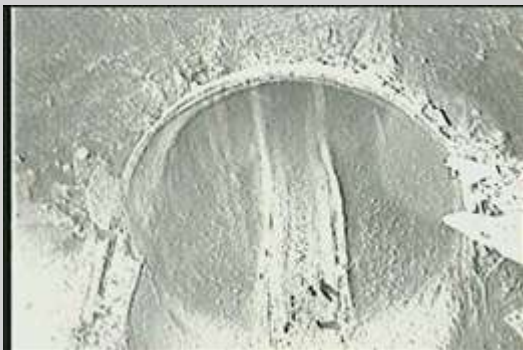
Pipe In @ 9 O'Clock

Pipe Material: **Unknown** ☒ Pipe Lined

Infiltration: **None** Pipe Seal Cond: **Unknown**
